England Home Inspections
PO Box 406
Huntsville, Alabama 35804

11014 Crestfield Drive
Huntsville, Alabama 35803

Inspection Report for 11014 Crestfield Drive Huntsville, Alabama 35803.inspx

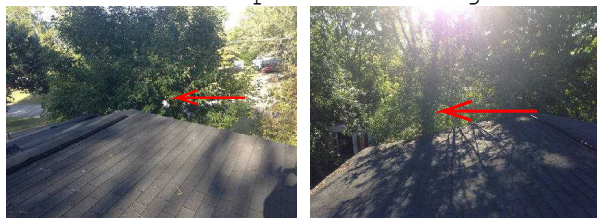
1. Driveway: Concrete
2. Sidewalks Concrete
3. Patio: Concrete
4. Front Porch enclosed porch
5. Grading: Minor slope
6. Drainage Appears serviceable
7. Vegetation: Trees and shrubs --- Recommend cutting back all trees and shrubs that are close enough to touch the house during windy conditions to prevent damage to the house.

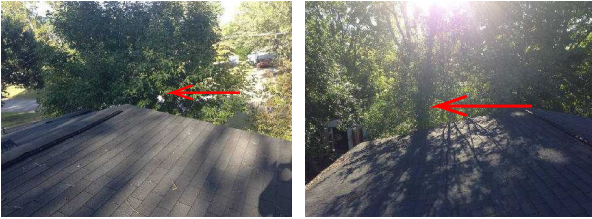
1. **Vegetation:** Trees and shrubs --- Recommend cutting back all trees and shrubs that are close enough to touch the house during windy conditions to prevent damage to the house.
