England Home Inspections
PO Box 406
Huntsville, Alabama 35804

11014 Crestfield Drive
Huntsville, Alabama 35803

Inspection Report for 11014 Crestfield Drive Huntsville, Alabama 35803.inspx

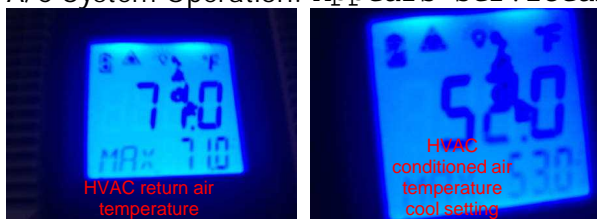
1. A/C System Operation: Appears serviceable

2. Condensate Removal: PVC
3. Area Served: whole building Approximate Age: 6 Years
4. Fuel Type: 220 VAC Temperature Differential: 19 degrees
5. Type: Package heat pump Capacity: 2.5 Ton
6. Refrigerant Lines: Not Visible
7. Electrical Disconnect: Breaker disconnect

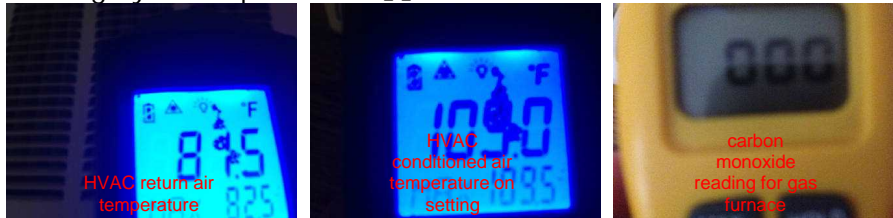
- 1. Heating System Operation: Appears Serviceable

- 2. Area Served: Whole building Approximate Age: 6 Years
- 3. Fuel Type: Natural gas
- 4. Flue Pipe: Appears Serviceable

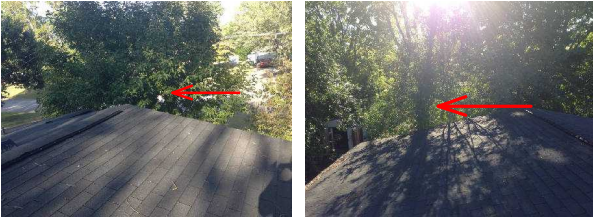
1. Vegetation: Trees and shrubs --- Recommend cutting back all trees and shrubs that are close enough to touch the house during windy conditions to prevent damage to the house.
